## Emergency Underpinning and Repositioning of a Four-Story Office Building

## EMERGENCY UNDERPINNING AND REPOSITIONING OF A FOUR-STORY OFFICE BUILDING

### ABSTRACT

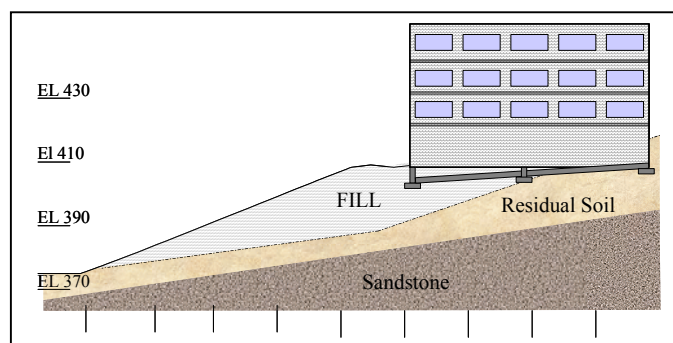
The structure is steel frame with brick and glass veneer, as well as cast in place concrete walls in below-grade areas (see Fig. 1). The ground surface slopes from the front of the building to the back with a change in elevation of about 14 ft.

*Fig. 1. Interpreted subsurface conditions.*

A cast-in-place concrete wall on the east side of this building supported one edge of the first floor slab. This wall was supported on a shallow strip footing independent from the column footings. Therefore, differential settlement was taking place between the wall and the rest of the structure. This caused deformation and loss of support of the first floor slab.

It is conceivable that, due to the soft condition, the fill materials may have compressed over time inducing the observed movements of the structure. During such a process, lateral movements may be a natural consequence of compression of the unconfined fill lying on the inclined incompressible substratum. Lateral displacements may be similar in magnitude to the vertical compression of the fill. Configuration of the connections of structural elements may have also contributed to the observed horizontal movements.

As indicated previously, movement of the slope was not considered to be the cause of the distress. The localized condition of the fill beneath the southeast corner foundation, resulting primarily in vertical compression under self weight as well as the weight of the building, was believed to be the most critical issue.

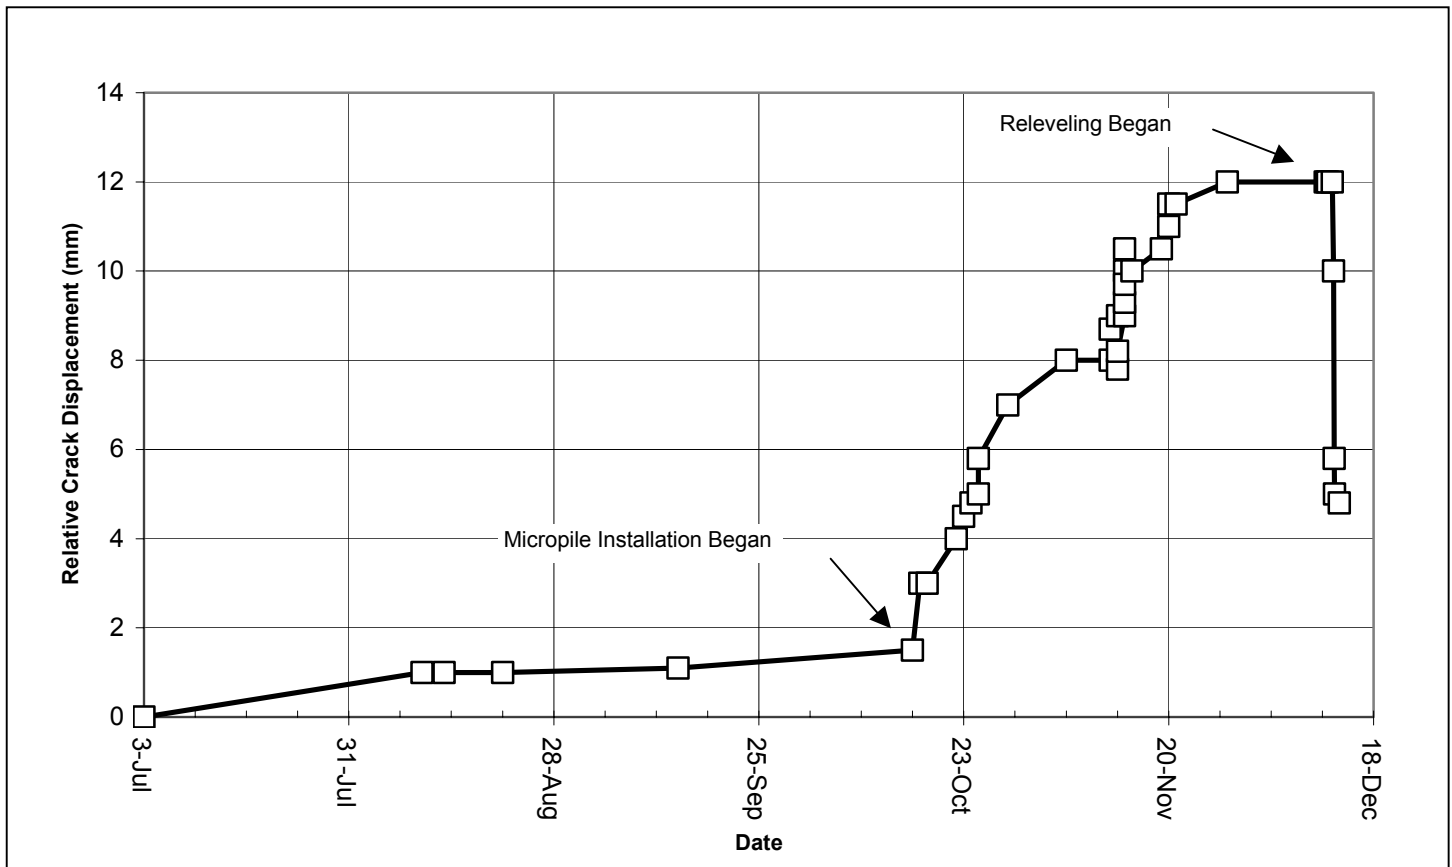
Six standard crack monitor gauges were installed to supplement several already installed by the structural engineer for the project. A graph of typical data is shown in Fig. 3.

In addition to the crack monitors, spot checks on the level of the first floor interior and exterior were made from the basement area. Based on measurements of the vertical crack widths inside the building, the total settlement of the southeast corner was estimated to range between 3 and 3½ inches. Optical observation of the southern and eastern exterior walls suggested that settlements of two to 2½ inches may have occurred after installation of the brick veneer. Given these measurements, it appears as though there was an original settlement of about one inch shortly after construction of the wall, and an additional two to 2½ inches of settlement since placement of the brick veneer.

Fig. 3. Crack monitoring data.

Crack gauge measurements revealed that lateral movement of the top of the east wall had apparently accelerated during installation of micropiles. In addition, some of the existing cracks in the brick veneer on the east wall had visibly opened farther. It is possible that micropile installation may have impacted the rate of settlement of the wall, and consequently increased the loss of lateral restraint provided by the first floor slab. However, the reasons for this accelerated movement were not fully known. Consequently, temporary bracing and shoring were installed to limit further movements of the east wall.

Total settlement recovery measured by the survey was approximately one inch at the southeast column, and ¼ inch at the south column location. The recovery is depicted in the deflection plot of Fig. 3.

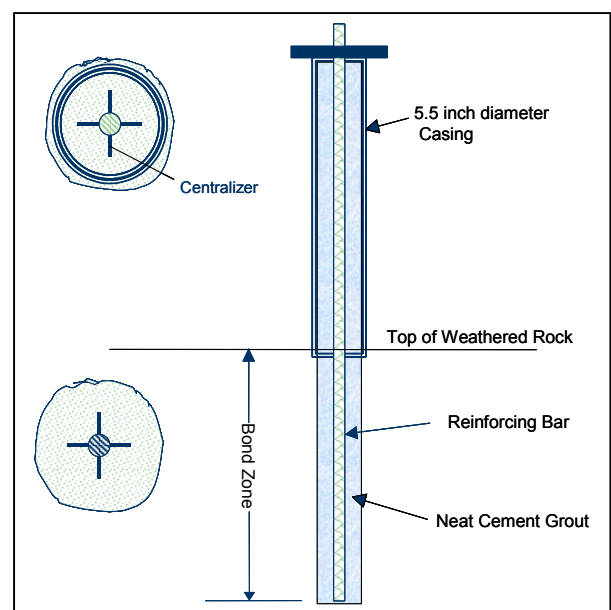
During drilling of the first micropile on the exterior of the east wall, the cuttings observed suggested that the upper 10 ft of rock were highly weathered and fractured. Given this information, micropile bond length was extended to 20 ft into rock since there was not a test program to confirm micropile capacities.

Fig. 4. Case I micropile (adapted from Bruce, 1988).

Drilling of each micropile was accomplished by end of casing flushing a 5.5 inch diameter casing under air pressure until reaching top of rock. Drilling through rock was performed with a downhole hammer to create a 4.5 inch diameter bond zone. The micropiles were filled by the tremie method with a neat water-cement grout with a specific gravity of about 1.8 and a design strength of 5,000 psi. Each of the micropiles was reinforced through the bond length with two No. 8 bars, Grade 60 ksi, with centralizers spaced at approximately 10 ft centers. Figure 4 shows a typical Case I (Bruce, 1988, 1989) micropile used for this project.

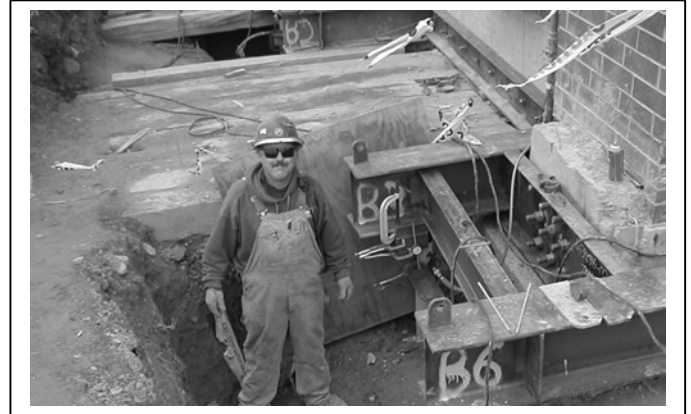
*Fig. 5. View of completed piles and steel grillage.*

A grill made of steel channel sections was designed to be slid under the existing wall and span across the top of the new piles (see Fig. 5). These channels were then bolted to the existing column pedestal. Steel bearing plates and steel keeper rings were welded to the top of the micropile and bottom of the steel channel at each micropile location. Twenty-five ton capacity hydraulic jacks were installed at each micropile location (see Fig. 6). Jacking manifold circuits were installed at each group of piles.

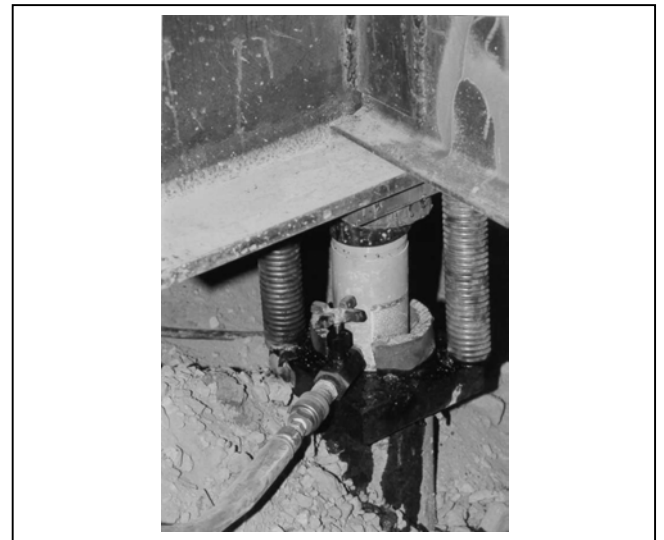
*Fig. 6. Twenty-five ton jack after repositioning and lock-off.*

Initially, the jacks were loaded to about 4,000 to 5,000 lbs to prestress the piles to the connection frame.

The jacking operation was considered complete after reaching the above settlement recovery values. No further jacking was attempted once the jack loads exceeded the estimated loads transmitted by the structure. The valves were closed on all of the pile jacks and two Williams All-Thread bars were welded between each pile bearing plate and the steel grillage to serve as a temporary lock-off mechanism until concrete was placed around the connection beams (see Fig. 6). The reinforcing steel was installed for the new pile cap, and concrete placement proceeded.
